IR NO. 69-15

UNDERSEA STUDIES
WITH THE DEEP RESEARCH VEHICLE
DEEPSTAR-4000

MARCH 1969

NAVAL OCEANOGRAPHIC OFFICE
WASHINGTON, D. C. 20390

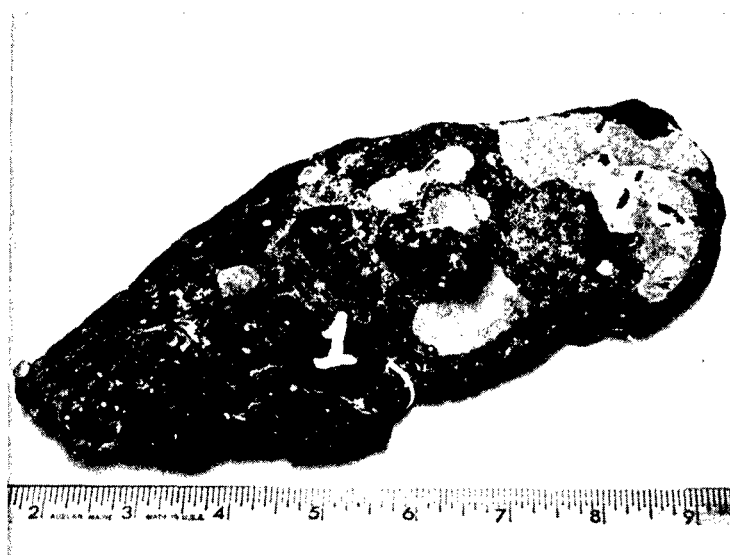
FIGURE 17. NODULE; FRANCOLITE IS PREDOMINANT MINERAL WITH ARAGONITE PARTINGS

featureless bottom covered with a coarse white carbonate sand containing many skeletal fragments. The only relief was an occasional oval-shaped depression with its major axis oriented along 060° parallel to the prevailing 0.2 knot current. These depressions were about 10 feet long, 5 feet wide, 6 inches deep, and appeared to be a result of current scour. After transitting about 1000 feet with the current, a series of ridges was encountered trending normal to the vehicle's course. These ridges, appearing to be sand waves, 3 to 8 feet high and 50 to 100 feet apart, had scour depressions on their northeast side. The crests of these ridges were covered with randomly-oriented rock slabs, likely manganese,^(1.) approximately 12 inches thick and one to three feet wide. Flat sandy areas 30 to 50 feet across with small-scale current ripples were evident between the ridges. A thin mottled pavement of manganese was present beneath this coarse sand layer. DEEPSTAR was unable to obtain a sample from this very hard pavement. During the remainder of the transit, alternating areas of flat pavement covered with coarse sand and low ridges with manganese slabs on their crests were continuously encountered. Typical bottom photographs and a sketch of the bottom features are shown in Figures 11 to 14. The Westinghouse Ocean Bottom Scanning Sonar (OBSS), as shown in Figure 15, was towed across this area and the resulting record appears in Figure 16. Figure 17 is a photograph of a nodule obtained on this dive.
